Debris/Ice/TPS Assessment and Integrated Photographic Analysis of Shuttle mission STS-105

**DEBRIS/ICE/TPS ASSESSMENT and
INTEGRATED PHOTOGRAPHIC ANALYSIS
OF SHUTTLE MISSION STS-105**

August 10, 2001

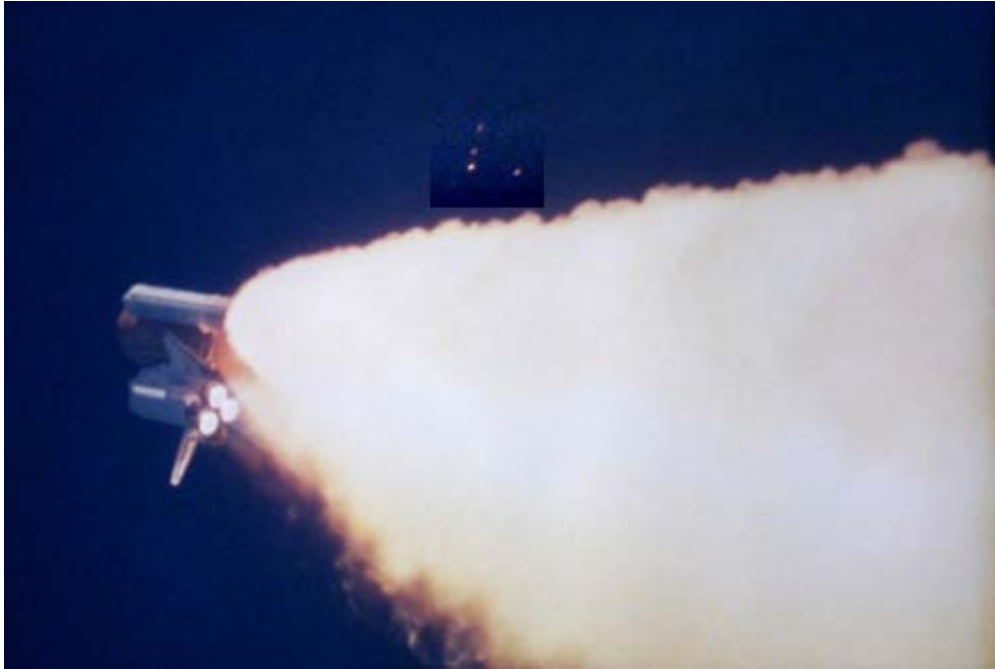
Figure 2.2.2(A) Debris Spray Seen Exiting the SRB Exhaust Plume (Camera E223)

As on previous missions, debris was seen exiting the SRB exhaust plumes. The debris exiting the SRB exhaust plumes during the majority of the ascent was probably instafoam from the aft end of the SRB's. The more dense appearing debris near the time of tail-off, just prior to SRB separation, was probably SRB slag debris. Examples of this debris can be seen in Table 2.2.2 (B).

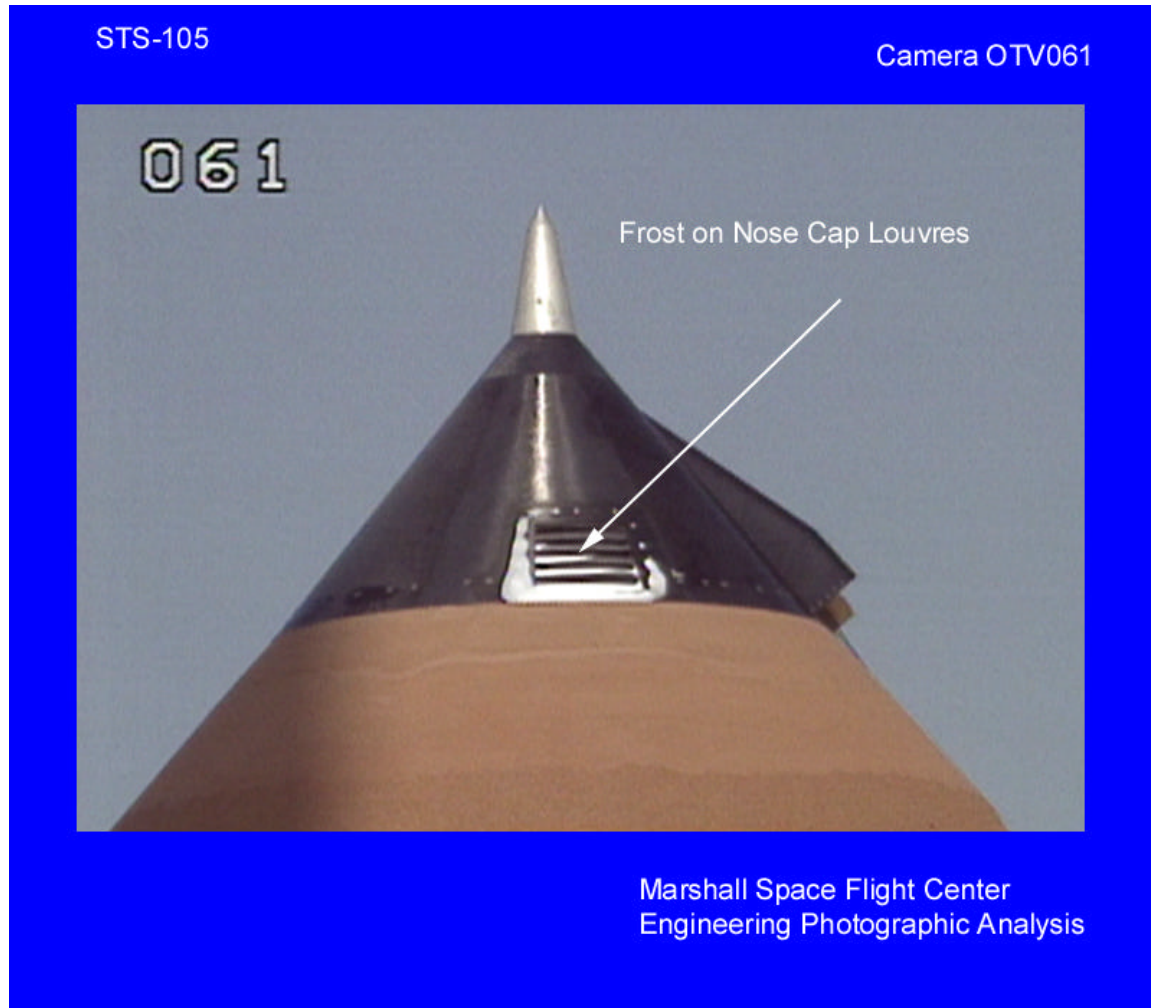
Figure 1. Frost on ET Nose Cap Louvers

Frost was observed on the External Tank Nose Cap Louvers prior to liftoff.

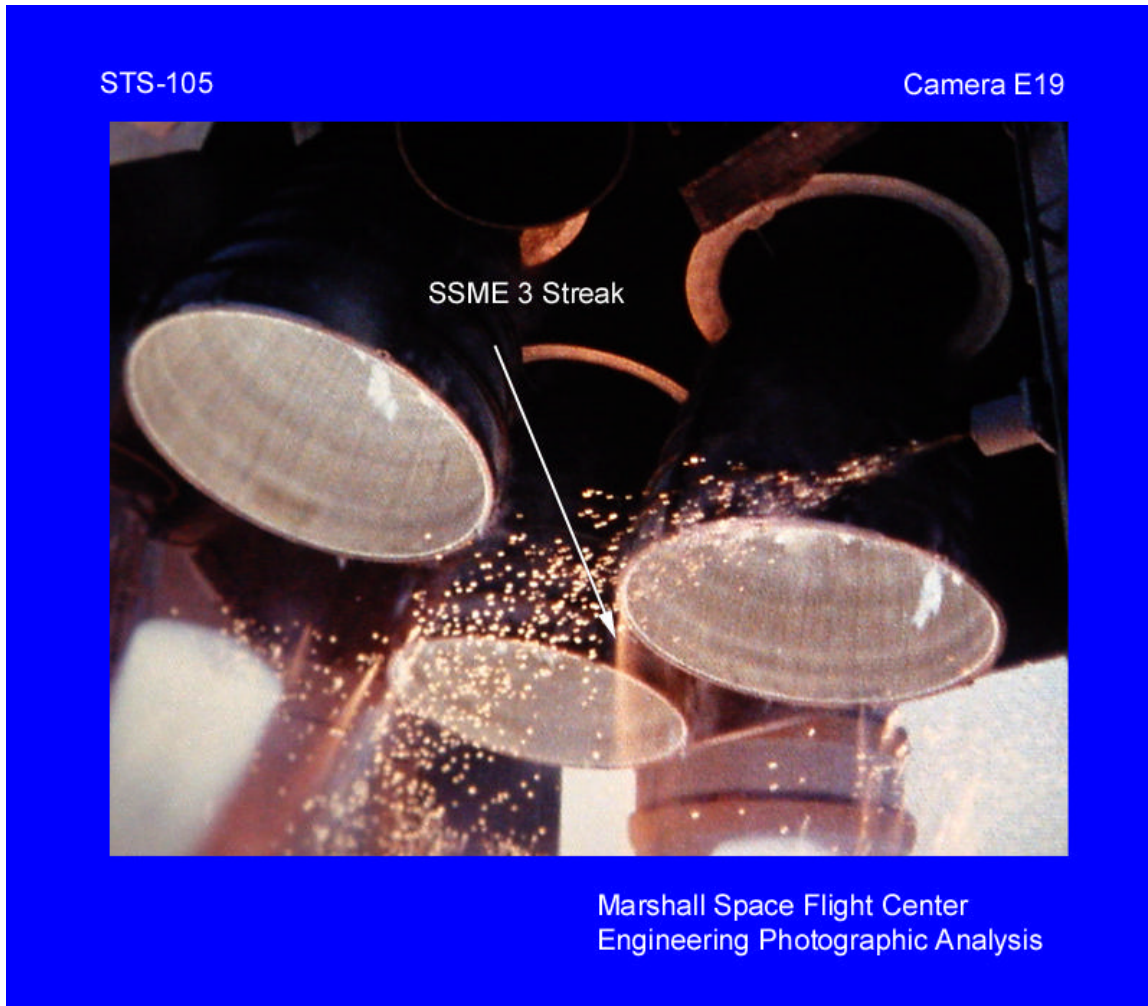
Figure 3. Streaks in SSME #3 Plumes

Several streaks were also observed in SSME#3 plumes prior to launch. Timing for these streaks: 222:21:10:12.078 UTC, and 222:21:10:13.380 UTC.

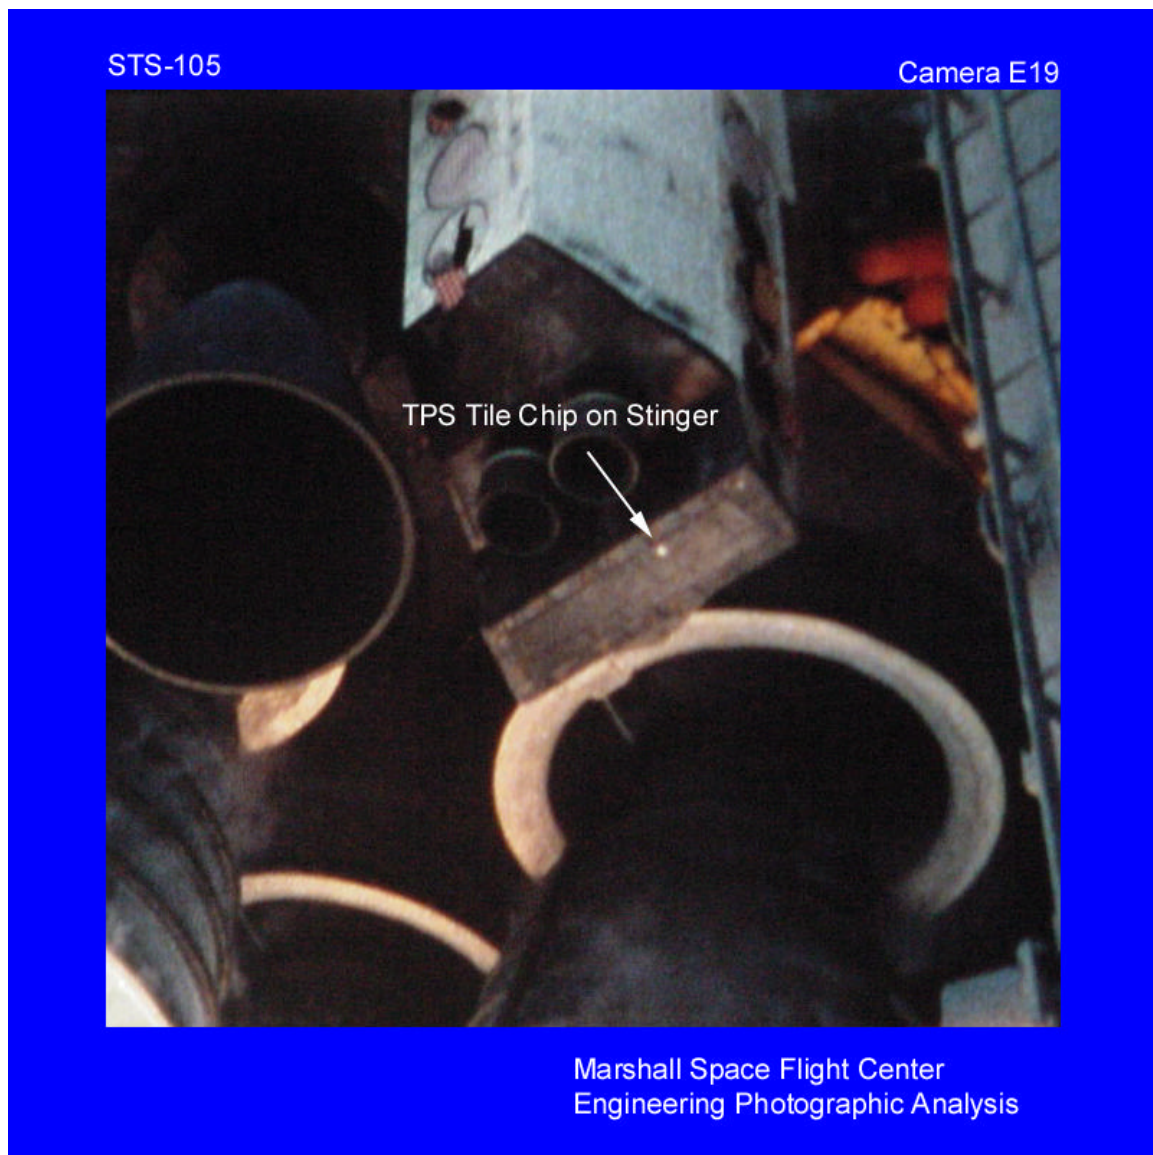
Figure 4. Chipped Tile on Right Stinger Pod

A chipped tile was observed on the Right Stinger Pod.
